TECH NOTE

Recalibrate SmartTouch SVT43 Screen

SmartTouch keypad (P/N: SVT43)

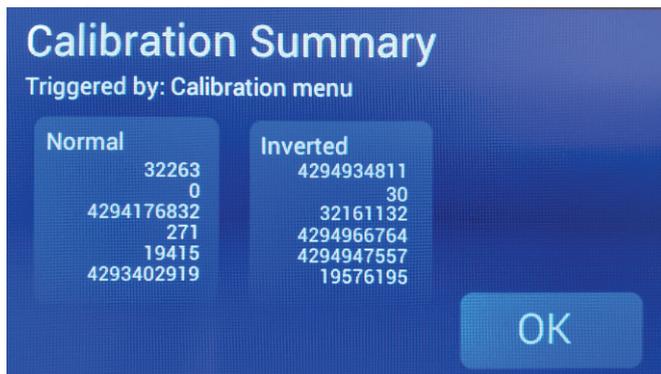
Finished

The summary page will appear after calibration

NOTE: values should be unique, no two the same
